Manhole Inspection Summary

Manhole # S49A__049MH

Insp Date: **5/7/08 2:14 PM**

Location Address: **228 n glover st**

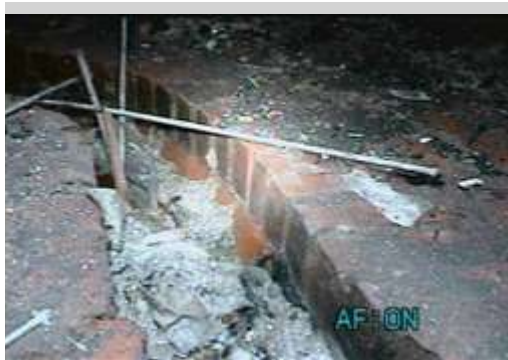
Defect 2

Condition: ☐ Sound ☐ Cracked ☐ Root Intrusion ☐ Deteriorated ☐ Leaks ☒ **Debris**

channel debris

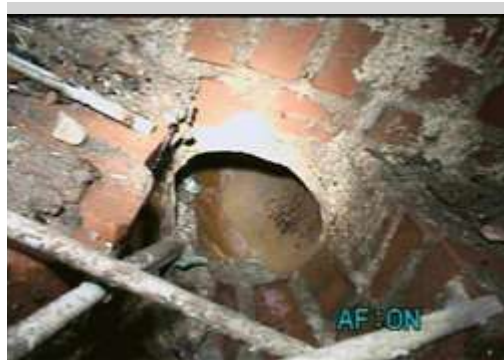
Defect 3

Condition: ☐ Sound ☐ Cracked ☐ Root Intrusion ☐ Deteriorated ☐ Leaks ☒ **Debris**

Bench debris

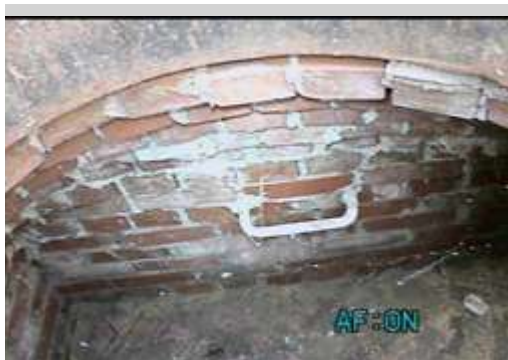
Defect 1

Steps Count: **1** Missing: **0** ☒ **Corroded**

step

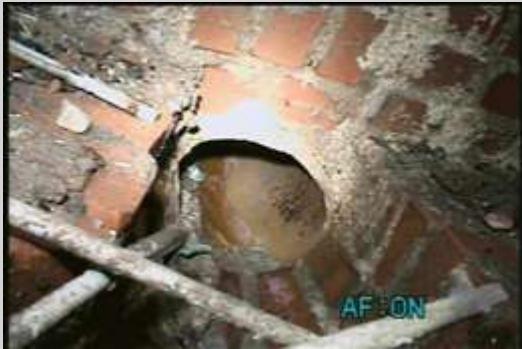
12 O'Clock Outflow

8 in. Circular Gravity Sewer
Pipe Out @ 12 O'Clock

Pipe Material: **Clay** ☐ Pipe Lined

Invert Depth: **6.71** (ft.) Flow Characteristics: **None**

Deposits: ☒ None ☐ Mud ☐ Sludge ☐ Debris ☐ Grease

Infiltration: **None** Pipe Seal Cond: **Unknown**

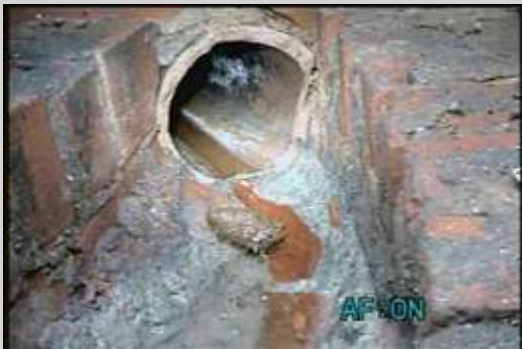
5 O'Clock Inflow

8 in. Circular Gravity Sewer
Pipe In @ 5 O'Clock

Pipe Material: **Clay** ☐ Pipe Lined

Invert Depth: **5.31** (ft.) Flow Characteristics: **Slow**

Deposits: ☒ None ☐ Mud ☐ Sludge ☐ Debris ☐ Grease

Infiltration: **None** Pipe Seal Cond: **Unknown**
